## Natural Watercourse from Haygate towards Bramham Beck

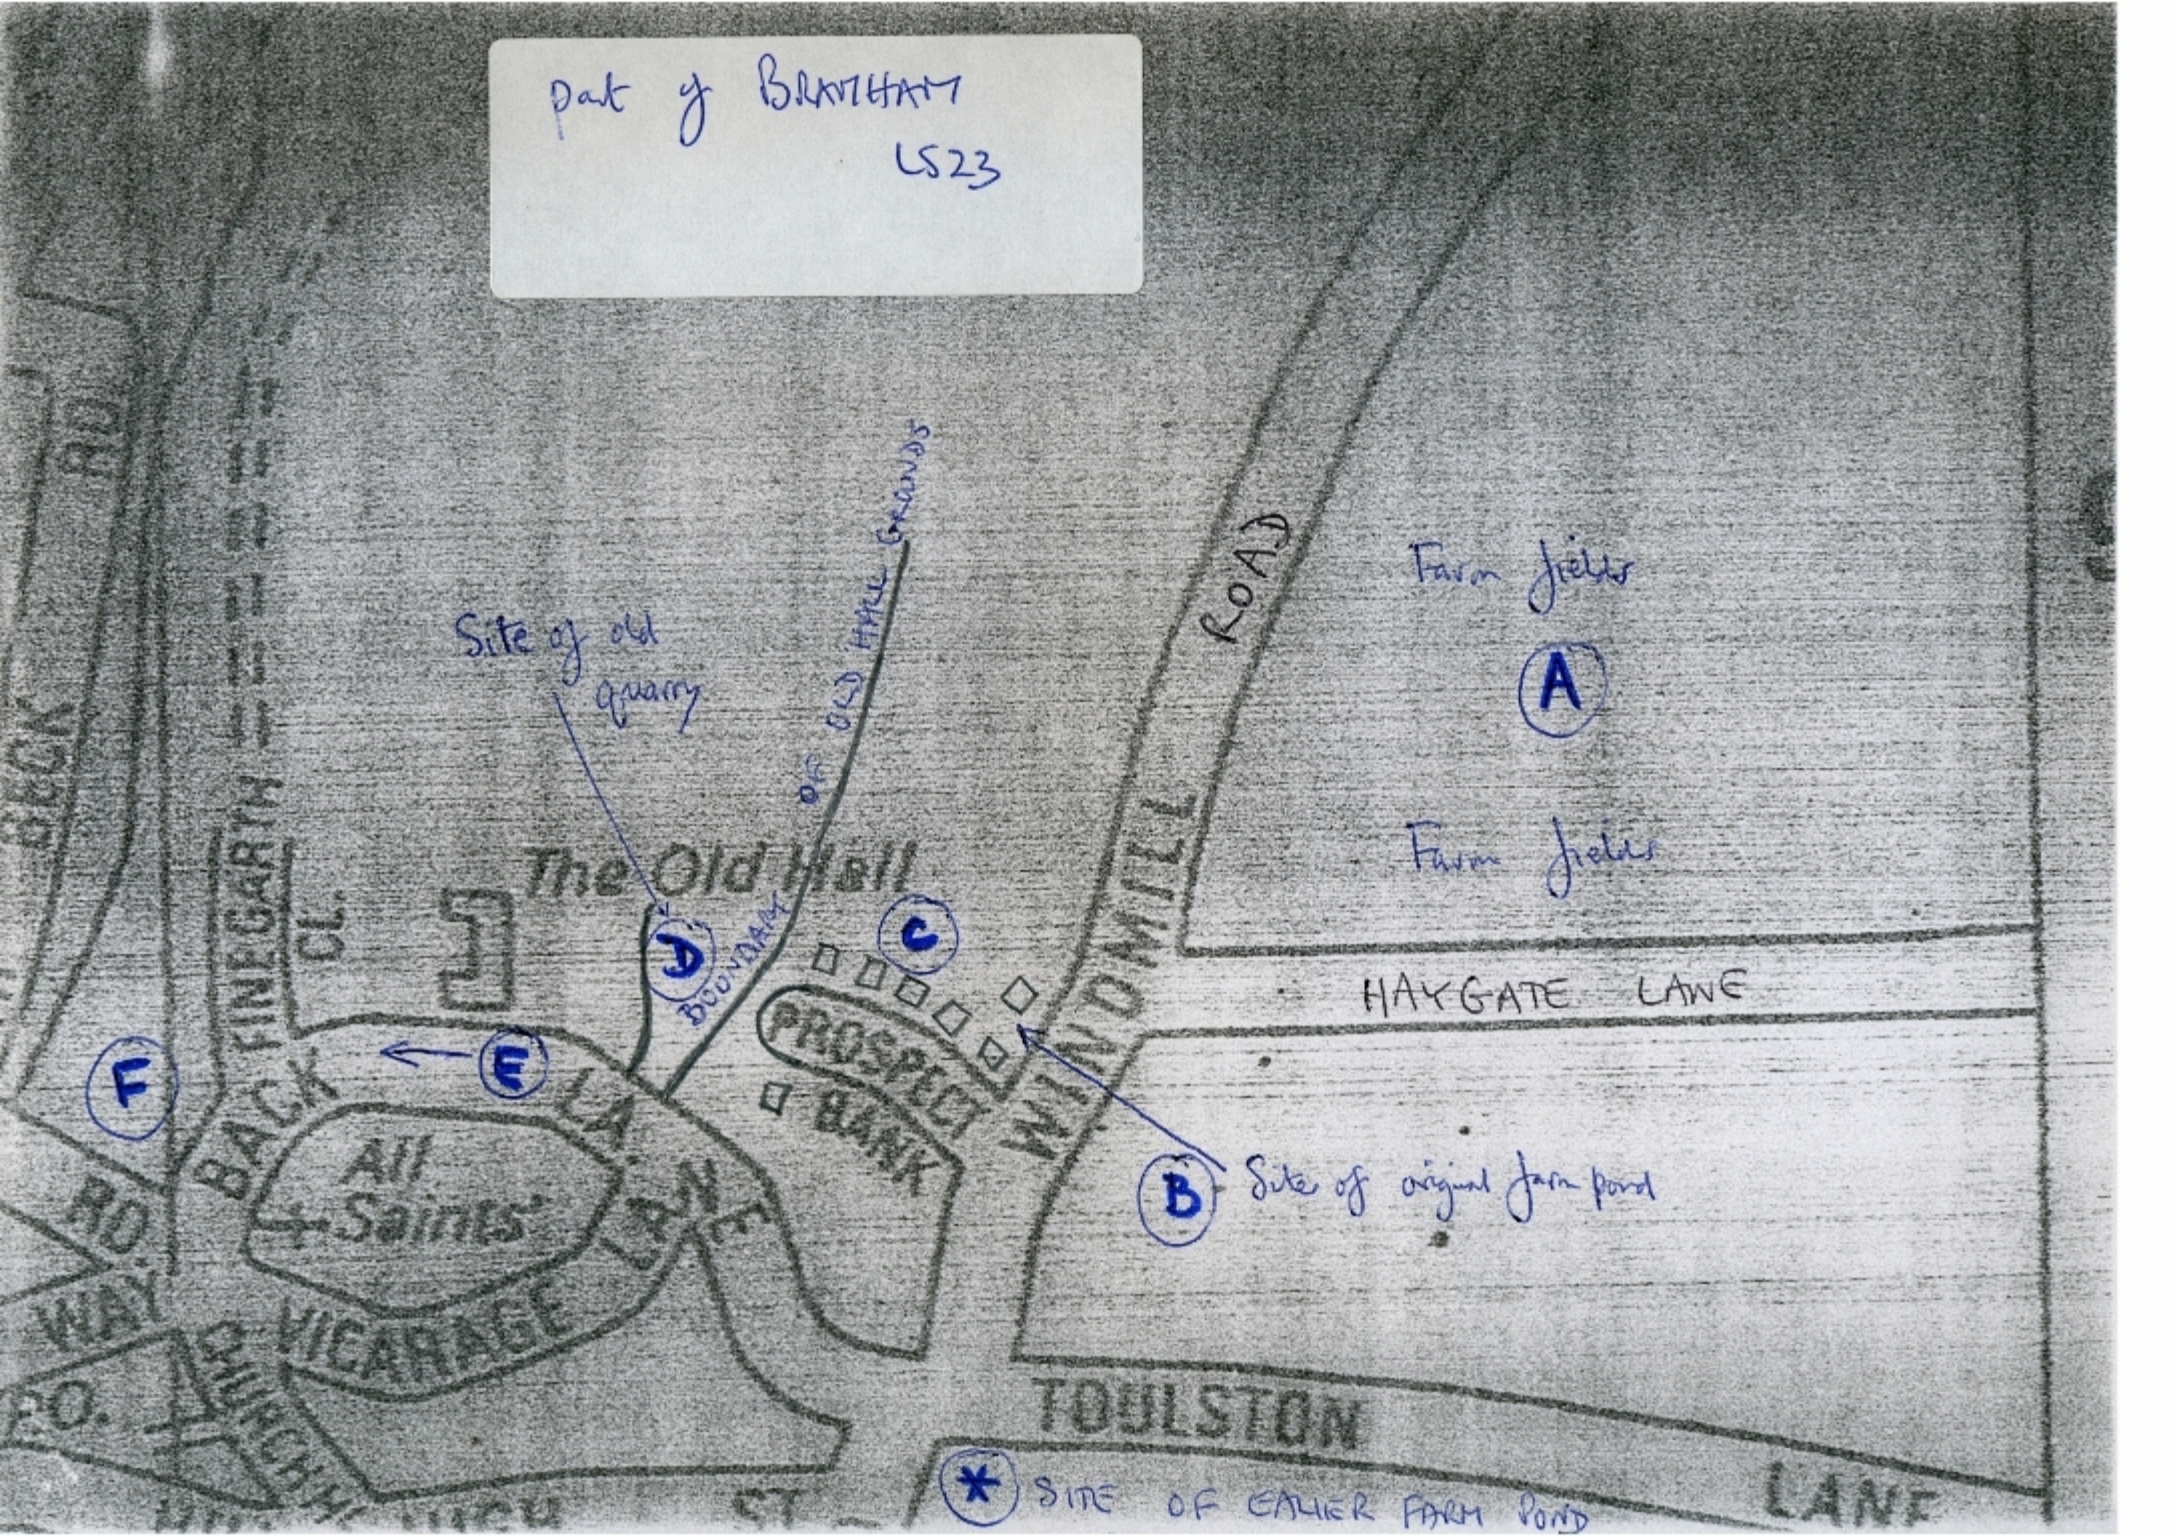
part of BRANTHAM  
LS23

Until the houses on Prospect Bank were built around 1970 , and the old quarry at the Old Hall was filled in by a previous occupant c. 10 years later , there was a natural [ and, at times of heavy rain , regular ] watercourse taking the overflow down to the Beck . This is shown on the included sketch.

When the farm fields [ A ] became inundated , water ran down Heygate and across Windmill Lane into the Prospect Farm pond [ B ] , on which nos. 8 & 9 Windmill Road now stand. If there was further overflow downhill [ westwards ] , it ran across what are now the gardens of the houses on the north side of Prospect Bank [ C ] into the old quarry just inside the boundary of the Old Hall [ D ] . From there , once the quarry had filled , it escaped through the drainpipes still to be seen in the quarry wall under the chestnut tree , down Back Lane [ E ] , often causing flooding at the cottages on the east bank of the Beck [ F ] . There was another farm pond [ \* ] at the meeting of Windmill and Toulston Roads which also alleviated problems with surface water at the high , east , end of the village; that too has gone.

Since the building of Prospect Bank, and the filling in of the Old Hall quarry , 1970 -80 approx., flowing water from Heygate has streamed across the back gardens of the northerly houses on Prospect Bank [ C ] , and escaped in two ways . Some water takes its old route into the site of the quarry , and down Back Lane ; the rest flows onto Prospect Bank , and away down the drains. The building of Prospect Bank , and the filling in of the quarry , have taken away the two natural reservoirs which ameliorated the flooding of Back Lane. Thus, during the period 1970 - 2000+, at times of heavy , continuous rain , there has been the increased likeliness of flooding at the bottom of Back Lane , to the east of the Beck [ F ] . This flooding has been made worse by the lack of regular maintenance by Leeds City Council who , despite having a theoretical 13 day cycle of street cleaning , rarely do so unless pressed . The result is that drains and gutters are frequently blocked when they are most needed.
